**ENHANCED PRELIMINARY ASSESSMENT REPORT
FOR TOOEELE ARMY DEPOT - NORTH AREA
TOOELE, UTAH**

**USAEC Contract DAAA15-93-D-0006
Delivery Order 001**

October 5, 1994

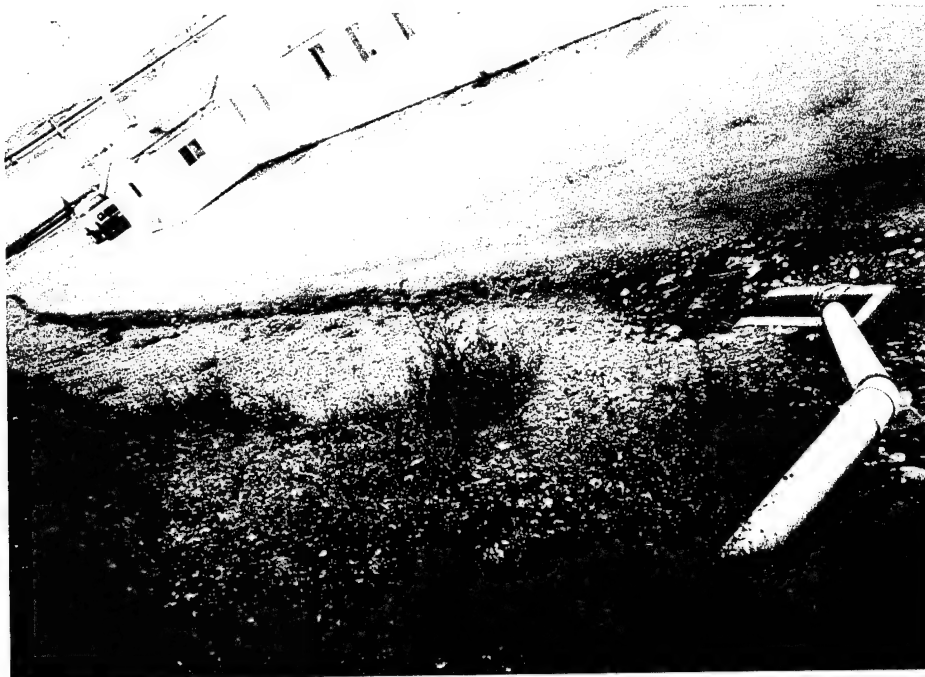
Photograph 1. (AREE 1a - Current Stormwater Sewer System). View Southwest of Storm Drainage Outfall Near Building 614.

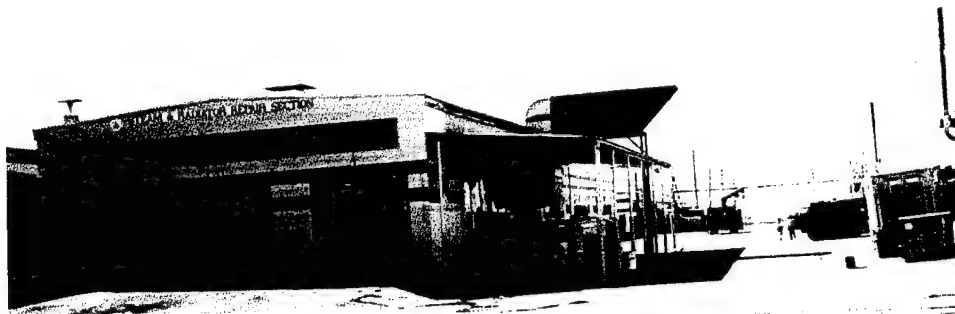
Photograph 2. (AREE 1c - Radiator Repair Facility). View of the Radiator Repair Facility in Building 609.

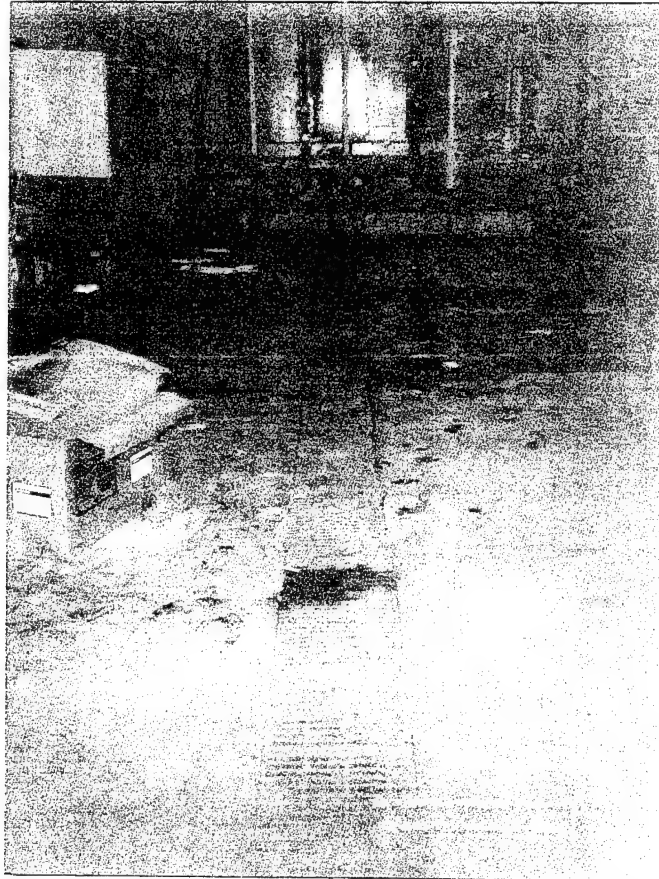
Photograph 3. (AREE 2 - SWMU 47: Boiler Plant Blowdown Water). View of Boiler Blowdown Sump in Building 637.

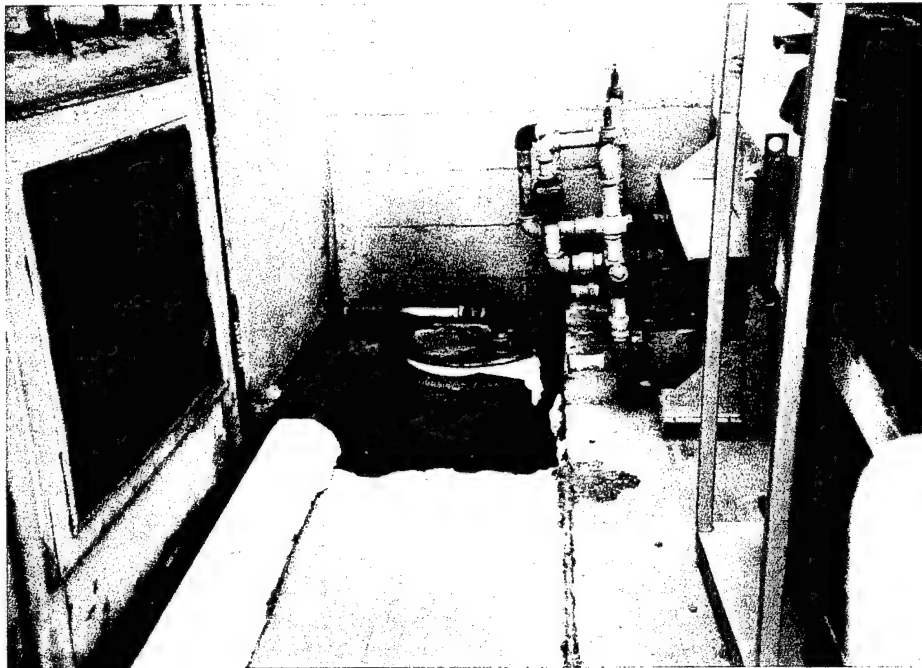
Photograph 4. (AREE 3 - Compressor Condensate Drain). View East of Compressor Condensate Drainage System Outside Building 619.

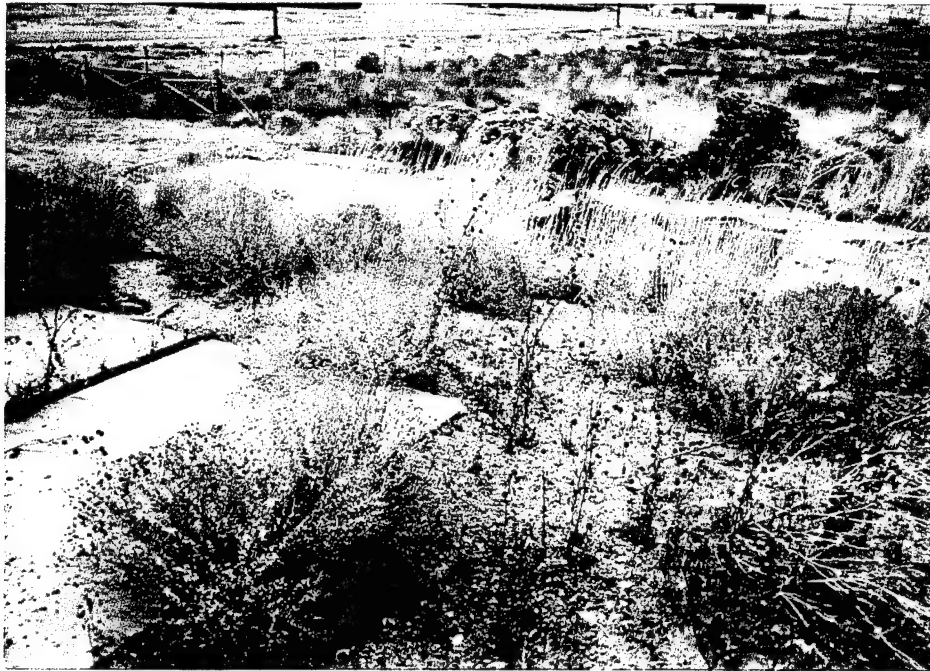
Photograph 5. (AREE 4 - SWMU 51: Chromic Acid/Alodine Drying Beds). View Northwest of Chromic Acid/Alodine Drying Beds Marked as Building 623.

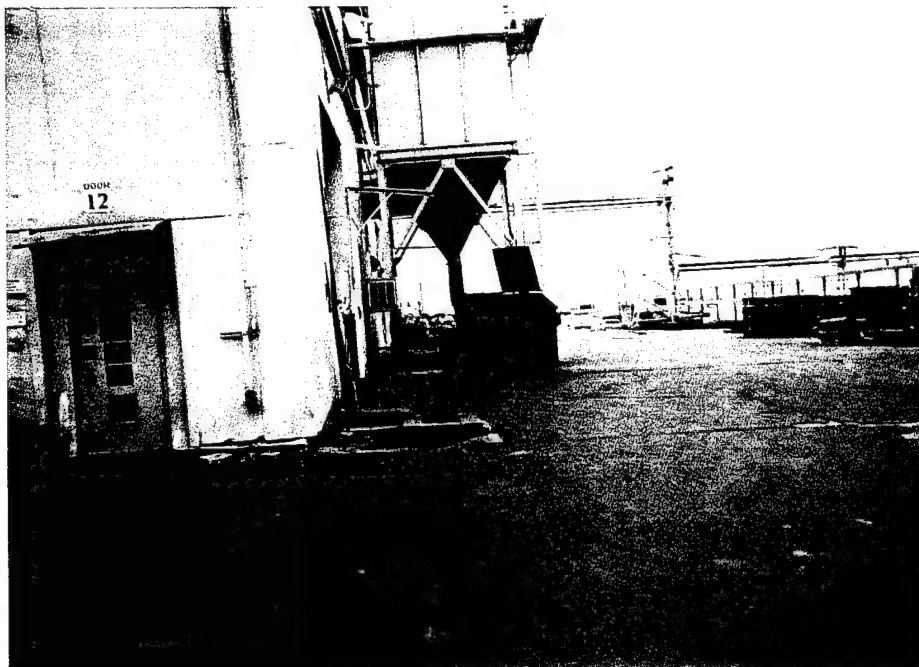
Photograph 6. (AREE 6 - SWMU 4: Sand Blast Areas). View South of Building 615 Sand Blast Grit Collection Area.

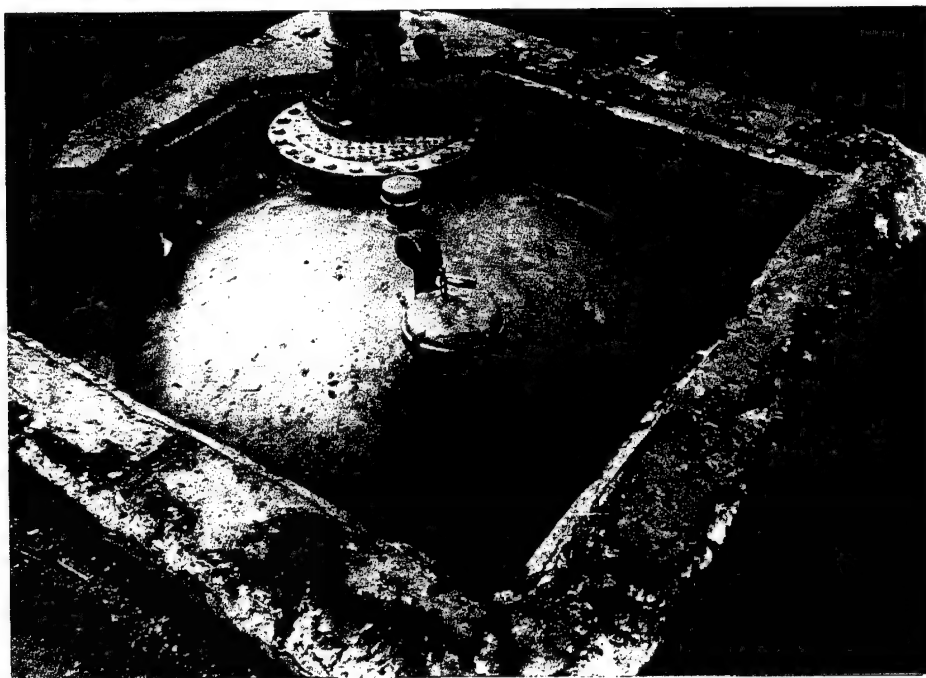
Photograph 7. (AREE 7 - SWMU 46: Waste Oil Dumpsters/Storage Tanks).
View of Used Oil Tank at the North End of Building 637.

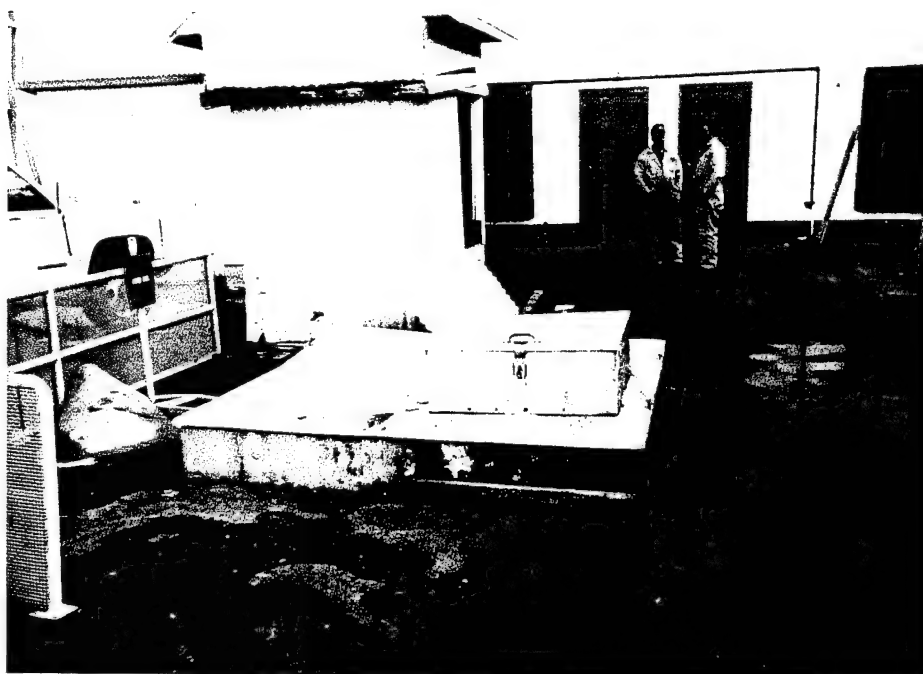
Photograph 8. (AREE 7 - SWMU 46: Waste Oil Dumpsters/Storage Tanks).
View of Underground Used Oil Tank at the South End of Building 637.

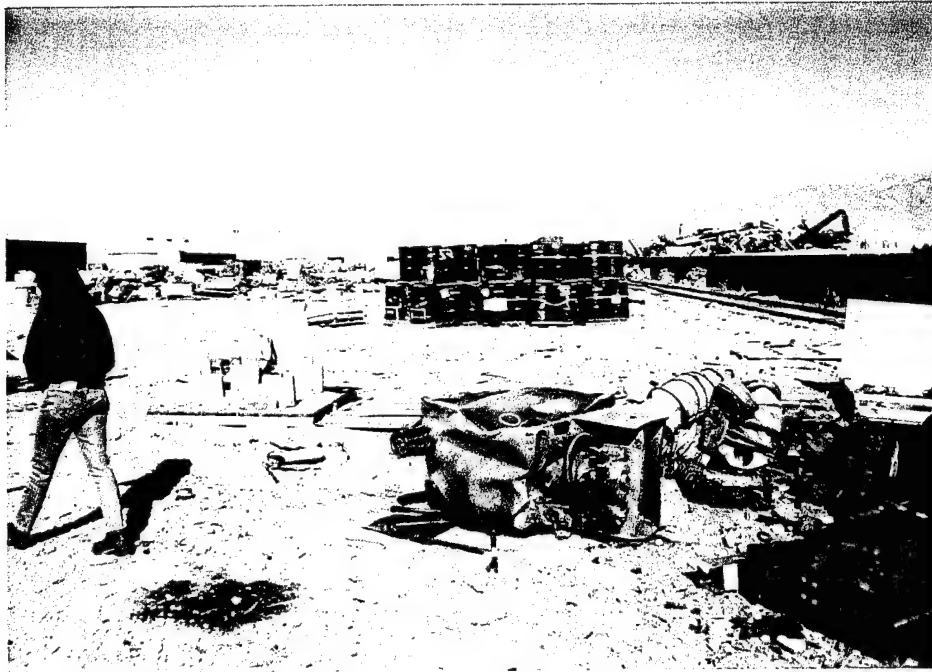
Photograph 9. (AREE 8 - SWMU 26: Defense Reutilization and Marketing Office Area). View North of the Defense Reutilization and Marketing Office Yard.

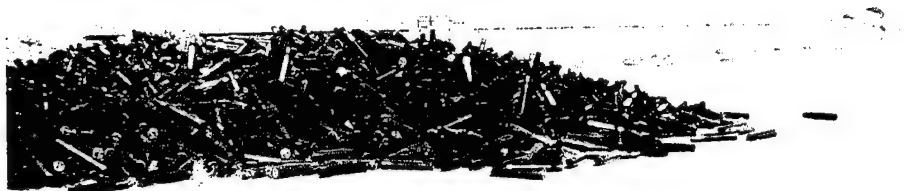
Photograph 10. (AREE 8 - SWMU 26: Defense Reutilization and Marketing Office Area). View North of 90mm Shell Casings Awaiting Sale in the Defense Reutilization and Marketing Office Yard.

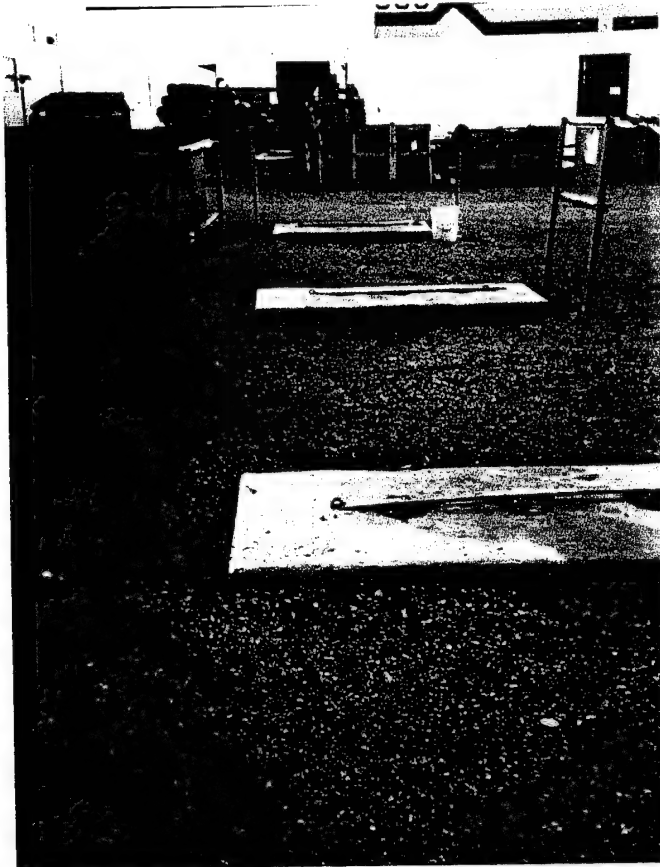
Photograph 11. (AREE 12 - Underground Storage Tanks). View South of Three Underground Storage Tanks Adjacent to Building 606.

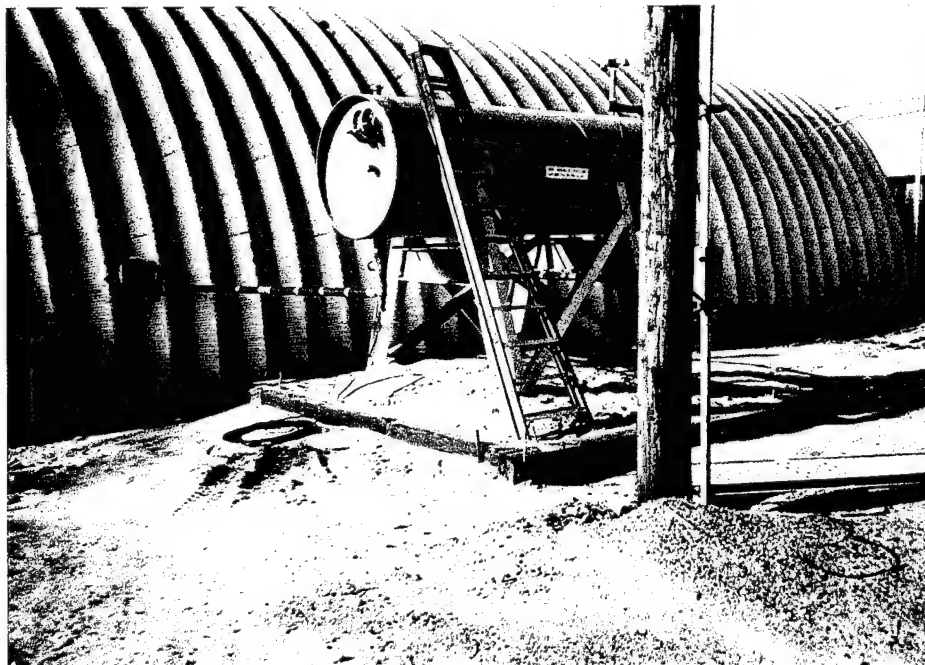
Photograph 12. (AREE 13 - Above Ground Storage Tanks). View Southwest of 1,500-Gallon Above Ground Diesel Storage Tank with Staining at the Base Adjacent to the Building on Open Storage Lot 655-5.

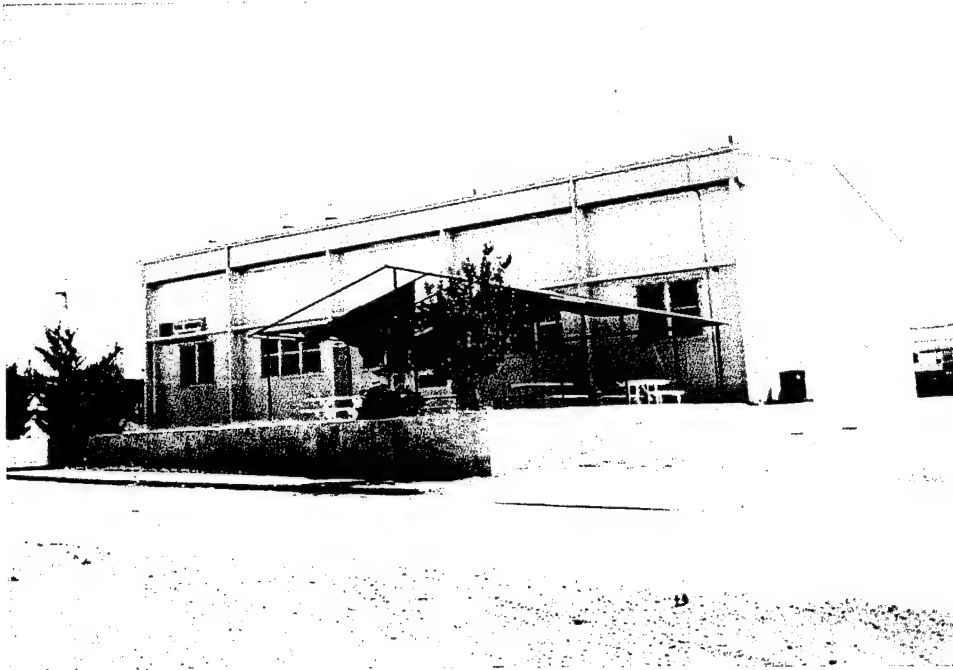
Photograph 13. (AREE 15 - SWMU 55: Battery Shop). View of the Former Location of the Battery Shop in Building 618.

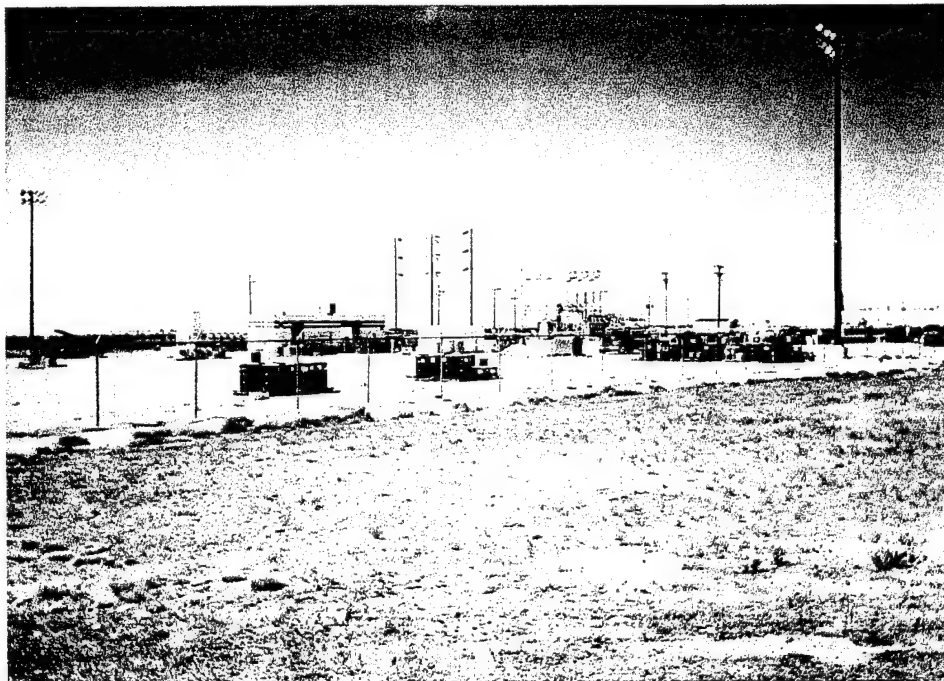
Photograph 14. (AREE 16 - SWMU 28: 90-Day Drum Storage Area). View Towards the Northwest of the 90-Day Drum Storage Area.

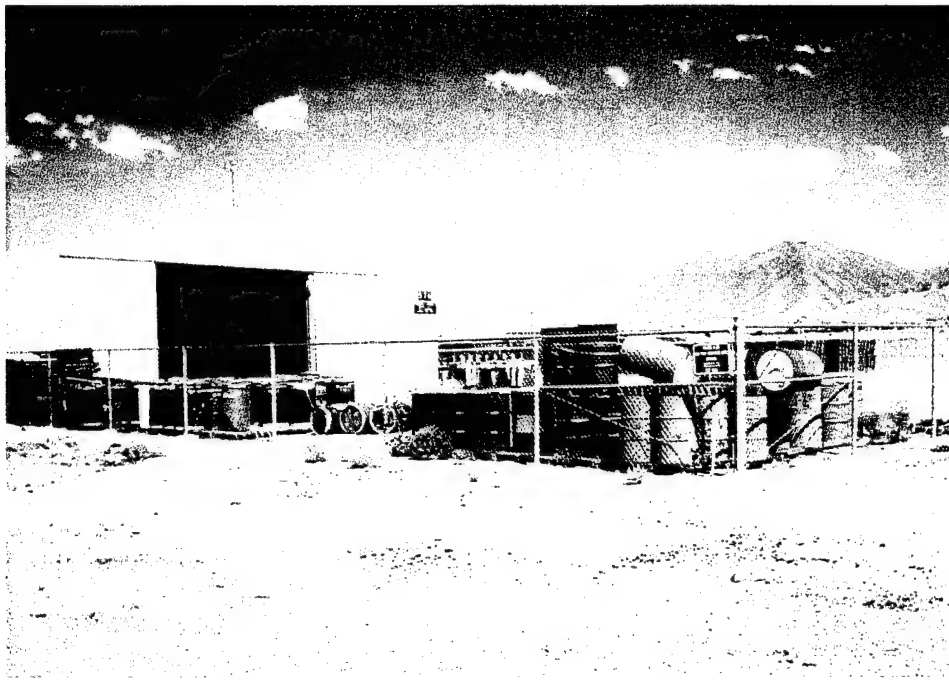
Photograph 15. (AREE 17 - SWMU 29: Drum Storage Areas). View to the Northeast of the Drum Storage Areas.

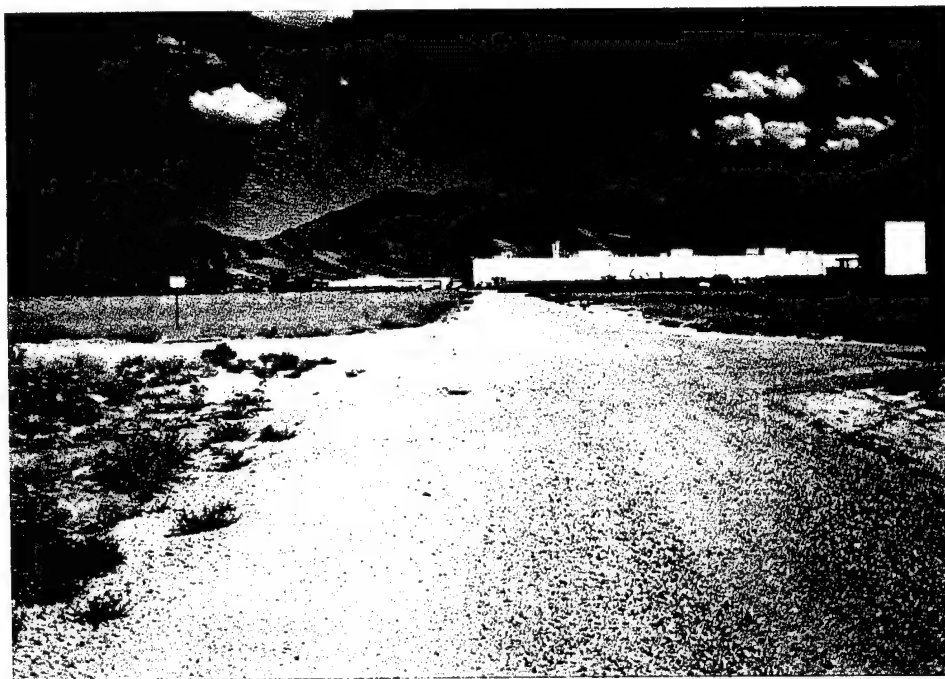
Photograph 16. (AREE 18 - SWMUs 2 and 30: Conveyance Ditches and Lagoons). View to the Southeast of the Location of a Former Drainage Ditch Along Avenue E.
